Assessing the Status and Effectiveness of Dykes in Lower Karnali River Basin, Rajapur Municipality, Bardiya, Nepal

1*Gaurav Neupane 1Ajay B. Mathema

1*School of Environmental Science and Management, Pokhara University, Nepal

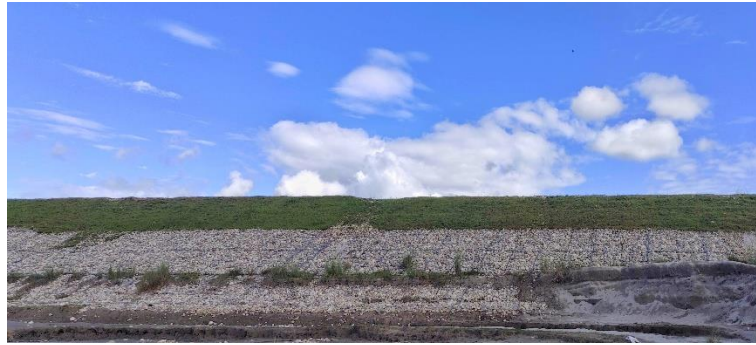
Figure 8: Riverside slope of the dyke

The stones of the river packed in the gabion mattress protect the slope of the dykes. These stones are round as well as angular which helps in slope protection.

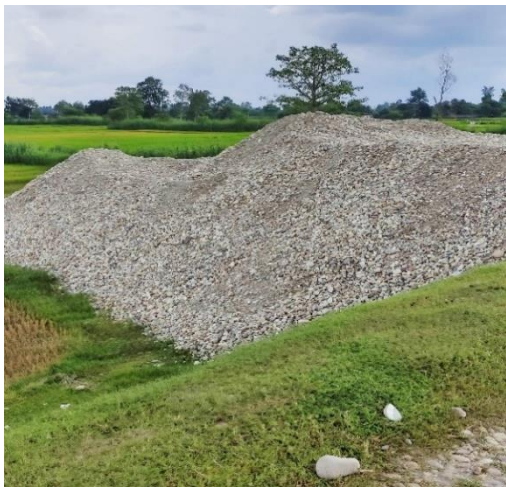
Figure 12: Materials for maintenance of dykes

There is a provision of pre as well as post flood inspection of dykes in lower Karnali river basin. Maintenance materials are also kept ready for the time of emergency. The top width of the dyke and the availability of turning platforms at every 1km helps for vehicular movement at the time of maintenance. Areas where dykes are destroyed or damaged are now maintained using big boulders on the slope which are often cost effective as well as requires little to no regular maintenance. In our FGD with village chiefs, they reported that when the dykes breach, the communities often donate their labor for the maintenance of the dykes. Similarly, they are also involved in cleaning of sluices as well as Kulos such as Bhadali Kulo. There is also a provision of excavation of river materials of Karnali River through tender. The excavation provides additional income to the municipality, as well as removes sediments deposited on the river.

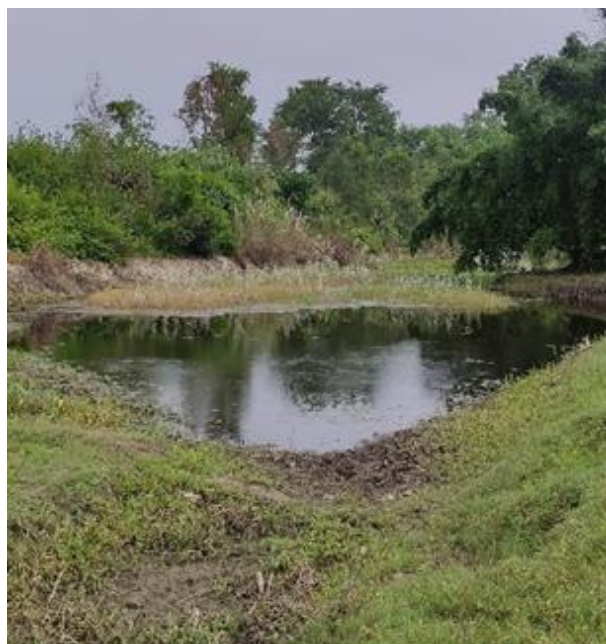
Seepage was also a problem, especially in Tighra (Ward 3) and Tihuni (Ward 1). Flood often gets stagnant in some areas behind dykes because of lack of passage/drainage from land to the river. The areas where seepage are a problem are shown in the figure below.

Figure 16: Stagnation of water behind dykes

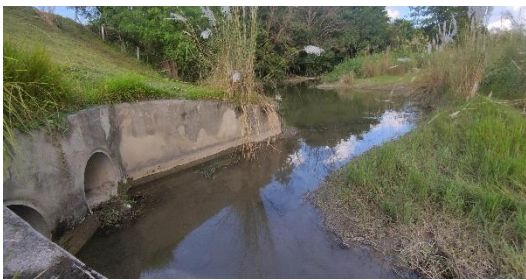
Water stagnation at AFS
